ATLANTIC COAST BASIN
NORTH BRANCH FORKED RIVER
OCEAN COUNTY
NEW JERSEY

LAKE BARNEGAT DAM NJ 00058

PHASE 1 INSPECTION REPORT NATIONAL DAM SAFETY PROGRAM

PHASE I INSPECTION REPORT
NATIONAL DAM INSPECTION PROGRAM
NAME OF DAM: LAKE BARNEGAT DAM FED #NJ 00058
AND NJ ID #271

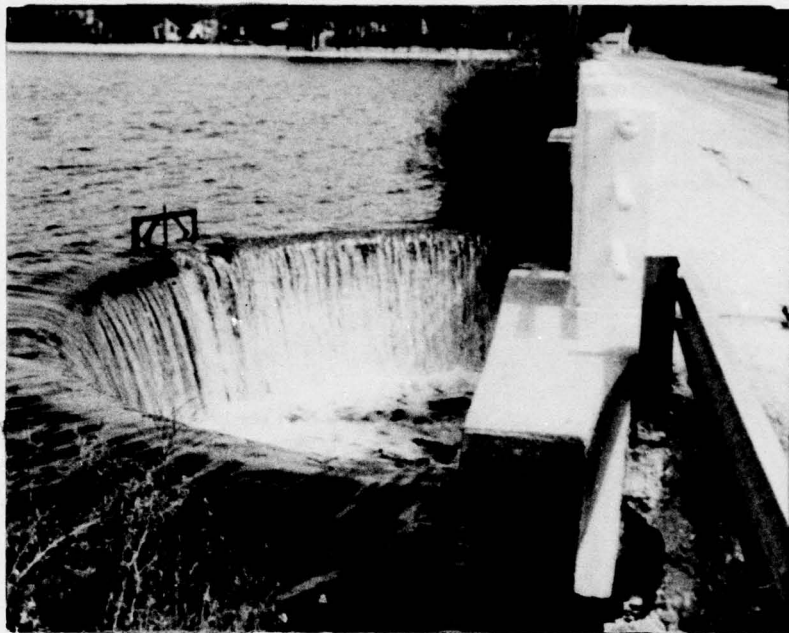
The reinforced concrete spillway is located 300 feet from the right abutment and displays severe weathering, reflecting its age and proximity to the ocean shoreline. It appears to be in an overall integral condition with

few major structural cracks. The horseshoe weir is in solid condition but the exposed crest and walls are skinned and the coarse aggregate is exposed. This may be the result of a highly acidic condition of the water (rather than a poor quality concrete). The depth of flow precluded a detailed structural inspection. The two vertical-lift sluiceways located at the third-points along the spillway appear to be abandoned and their gate wheels have been removed or vandalized. There is a considerable amount of silt in front of the dam but it could not be determined by probing whether or not the inlets were buried.

View of Spillway

The deteriorated areas of the exposed concrete surfaces should be patched, especially on the top of the curved crest of the spillway. Also the tops of all joints should be cleaned out and caulked.

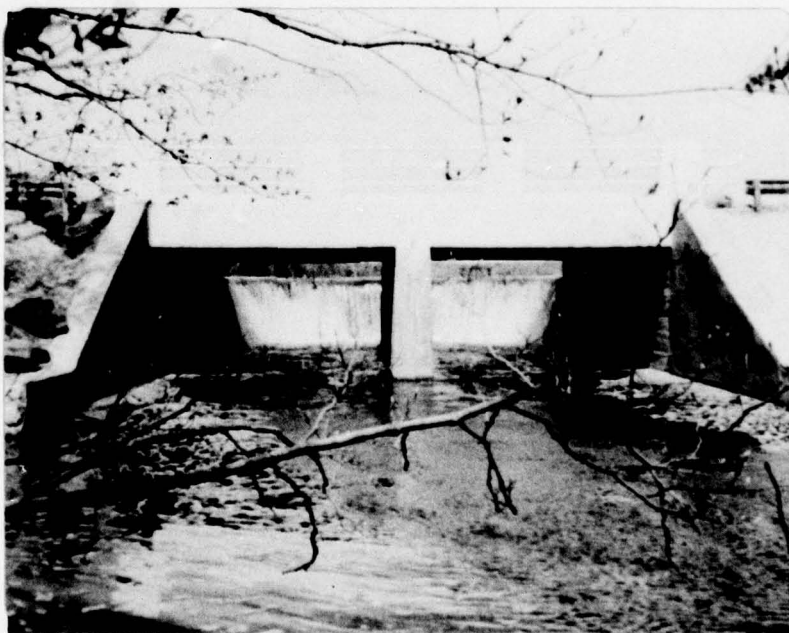
View of Spillway Outlet

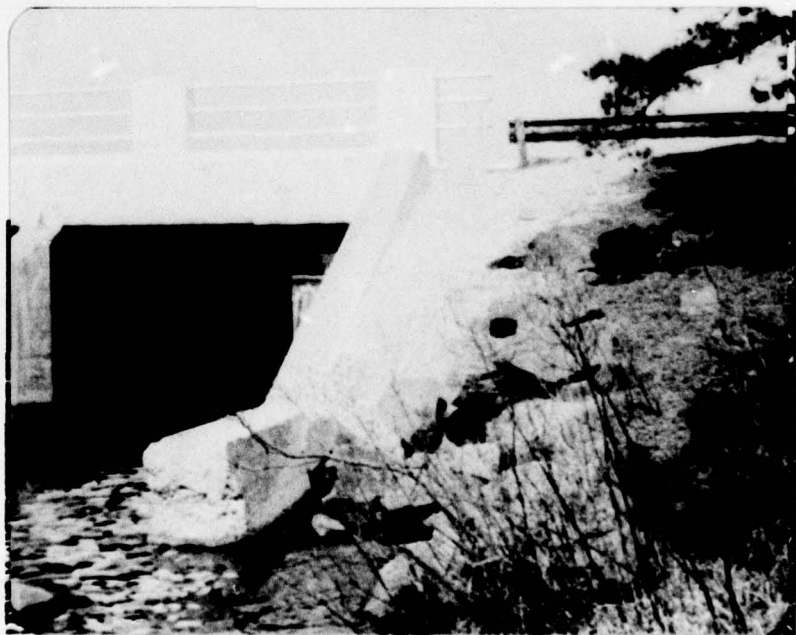
The bridge superstructure has 2 fifteen foot clear spans and is in satisfactory condition but the center pier and downstream wingwalls of the substructure have several pronounced cracks and spalled areas. The perimeter of the footings are protected by 3 inch T.&G. timber sheeting (12 feet long) but the walls are founded on spread footings and are not pile-supported; a questionable design configuration in the opinion of the inspection team. However, the structure has stood for almost 45 years with little evidence of serious differential settlement. According to construction records, the muck cedar swamp bottom soils were excavated down to elevation zero where a dense clean sand formed the load-bearing stratum.

View of Erosion - Left Wingwall May, 1979

- Regrade all slopes of embankment and reseed.
- Replace the scoured cavities along the upstream face with stone riprap or other heavy shore protection material.
- Install roadway curbs and drains on each side of the spillway bridge to channelize the surface run-off away from the structure.

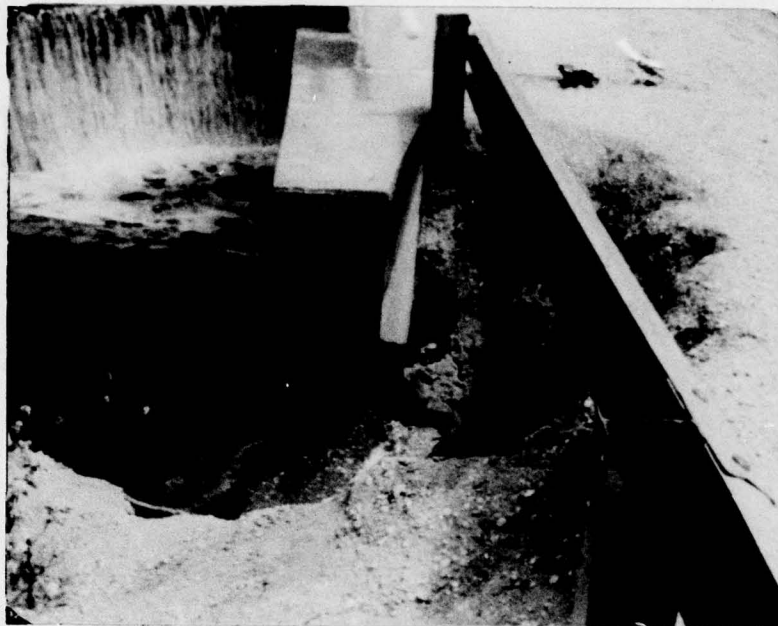
View of Erosion
